Manhole Inspection Summary

Manhole # S15SS1003MH

Insp Date: **6/20/07 11:16 AM**

Location Address: **CYLBURN AVE**

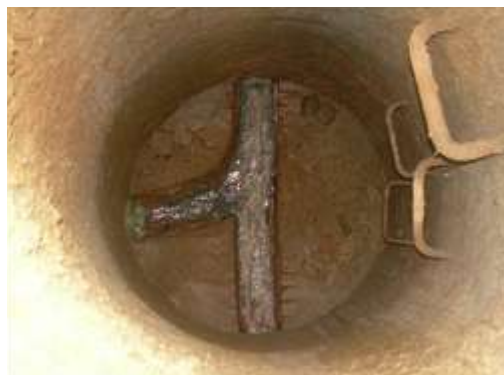
Top View

Corroded steps. Bench debris.

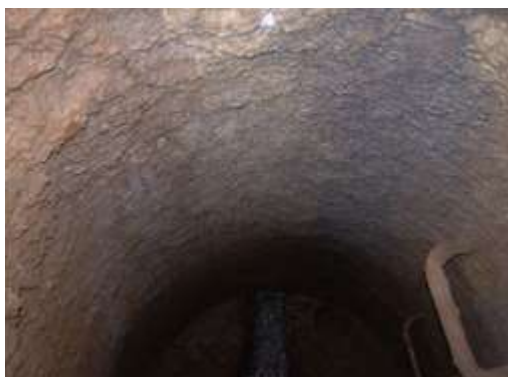
Defect

Corbel and Barrel infiltration.

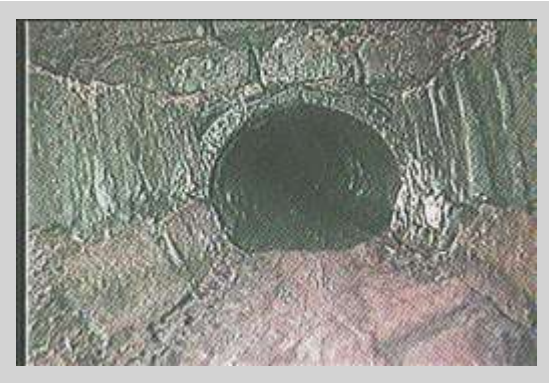
8 in. Circular Gravity Sewer Pipe Out @ 12 O'Clock

Barrel deterioration and infiltration. Channel deterioration.

Infiltration: **Evidence** Pipe Seal Cond: **Cracked**

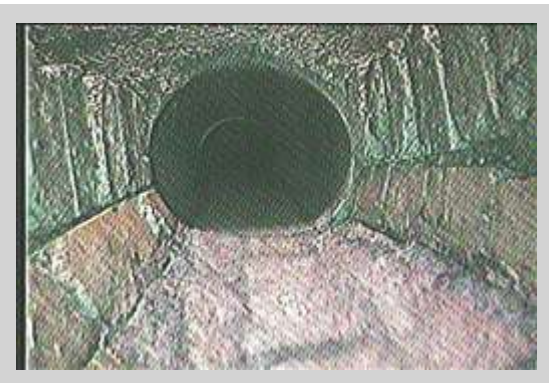
8 in. Circular Gravity Sewer Pipe In @ 6 O'Clock

Channel deterioration.
